WILLBAND CREEK ISMP

APPENDICES

October 18, 2019

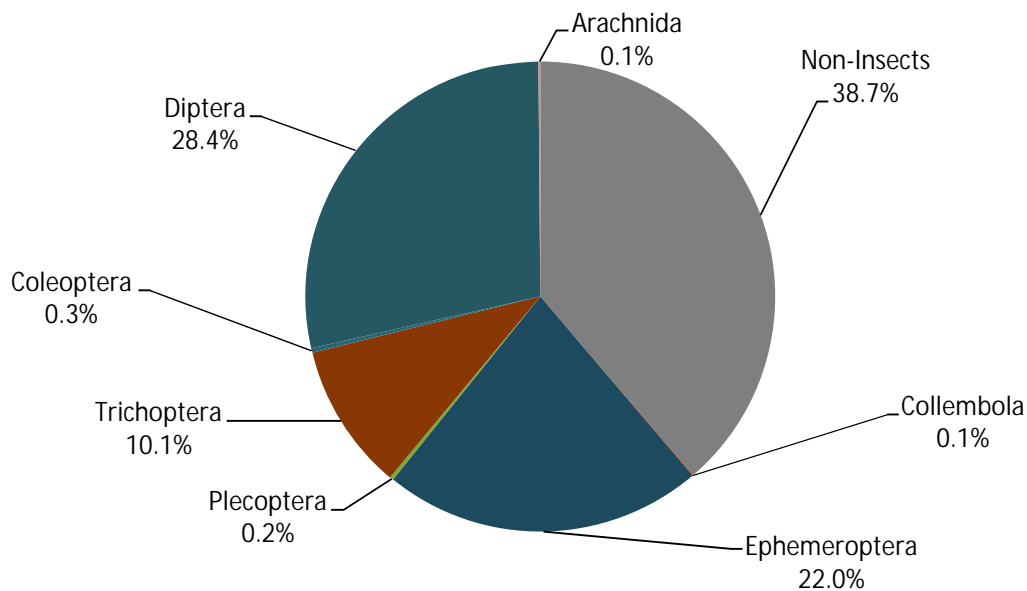
Figure 2: Horn Creek Community Composition¹

¹ Note: non-insects include annelida, mollusca, crustacea, and platyhelminthes

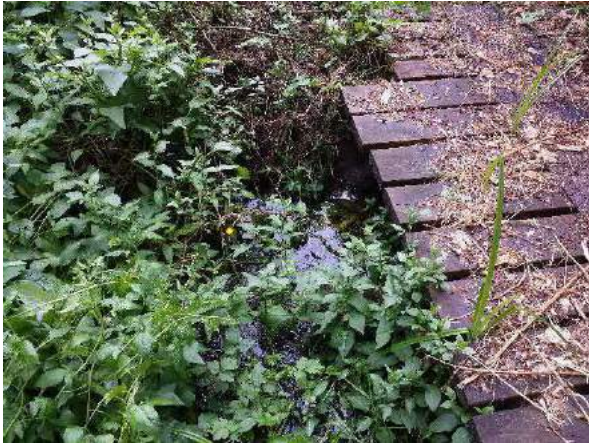
Photo 7: Small channel discharging to Willband Eastern Tributary (May 27, 2016)

It should be noted that existing mapping indicates two channels discharging into this section of the eastern tributary immediately south of Sumas Way on the Pratt Street alignment (see **Figure 1**). One channel is a swale located along the south side of a construction site at the intersection of Gladys Avenue and Sumas Way with minimal habitat value. The second is a wet area located to the east of the substation. A connection to the Eastern Tributary could not be confirmed.

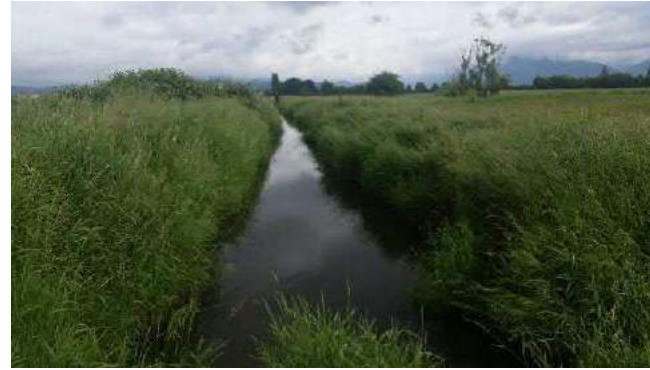
Photo 8: Blackham Creek, typical conditions on (May 27, 2016)

Blackham Brook is a channelized watercourse conveying flow directly north to the confluence with Willband Creek immediately north of Bateman Road (see **Figure 1**). It can be characterized as permanent, low gradient, linear channel with limited complexity. It was observed to consist entirely of run habitat with silt substrates. Large Woody Debris was not observed. The channel was up to 4.0 m wide with a depth averaging 1-2 m. Barriers to fish access were not observed.

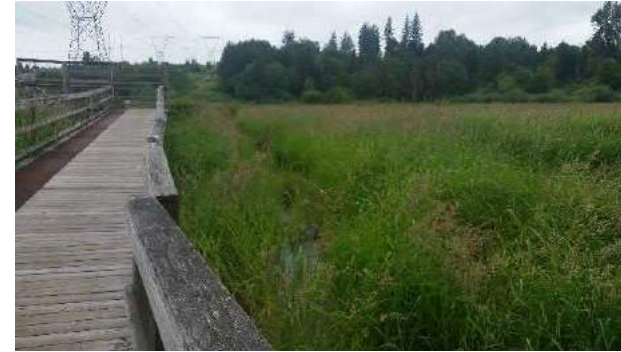
Photo 9: Evans Brook, typical conditions (May 26, 2016)

Evans Brook originates in a marshy area south of the terminus of Valley Road (see **Figure 1**). It conveys flow from both Thiessen Creek and Scott Brook to its confluence Willband Creek south of the Industrial Avenue alignment. The channel is permanent, low gradient and largely conveyed through a wetland area which also discharges to the stream via a series of small channels in the area. Channel morphology was observed to consist entirely of pool habitat. Substrate was an even mixture of silt and organic detritus. Habitat complexity was observed to be low. There was limited presence of Large Woody Debris. Barriers to fish access were not observed. There was a heavy presence of common duckweed which would tend to reduce dissolved oxygen within the water column as it decomposes.

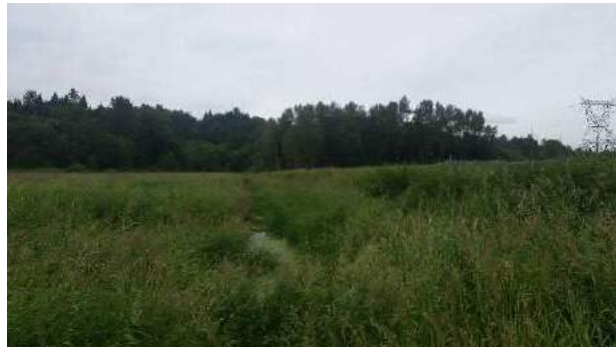
Photo 10: Evans Brook, typical conditions (May 26, 2016)

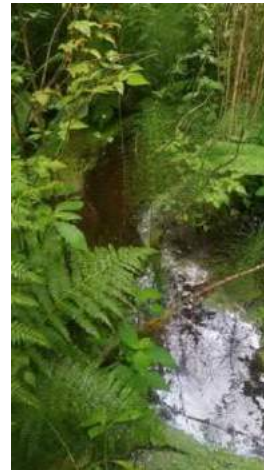
Photo 11: Scott Brook, typical conditions (May 26, 2016)

Scott Brook originates within a small ravine in a forested patch north of the Old Riverside Road alignment (see **Figure 1**). Flow is conveyed east, then south on a natural alignment. It enters a channelized section where it is subsequently conveyed directly east to its confluence with Evans Brook. The channel transitions from intermittent flow in its upper reaches to permanent flow downstream as observed at the time of the site assessment. The gradient is initially moderate before discharging to the low gradient channelized reach. Some meander to the channel is present in the upper reaches. Channel morphology was predominantly run habitat. The substrate was a mixture of silt (80%) and organic detritus (20%). Habitat complexity was observed to be moderate due to the presence of overhanging vegetation and some Large Woody Debris. Significant fish presence is not expected due to the small size of the channel, low water levels, limited refugia, and intermittent nature.

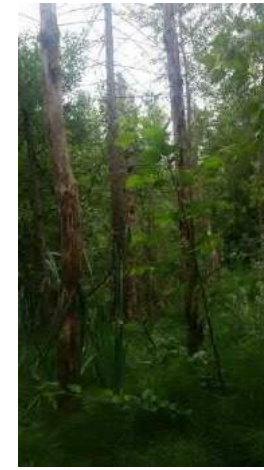
Photo 12: Scott Brook, riparian conditions (May 26, 2016)

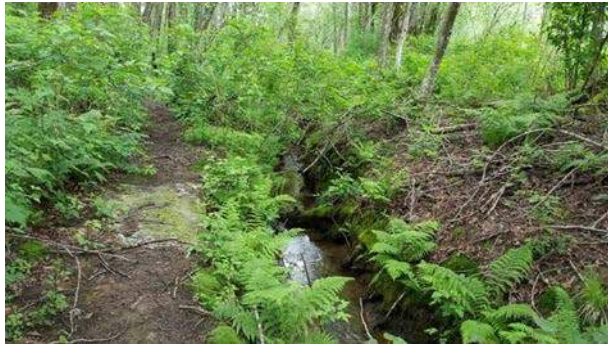
Photo 25: Upper Willband Detailed Assessment
(May 19, 2017)

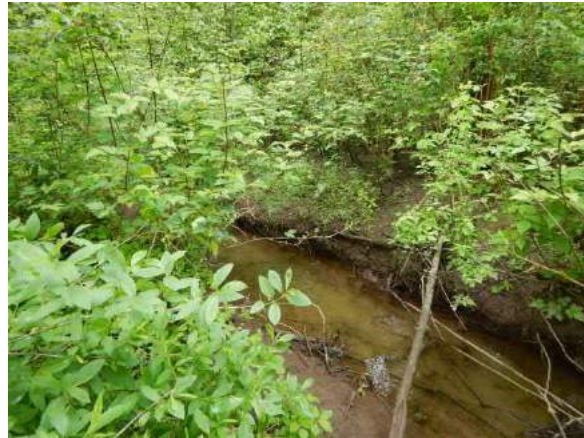
Photo 26: Upper Willband Detailed Assessment
(May 19, 2017)

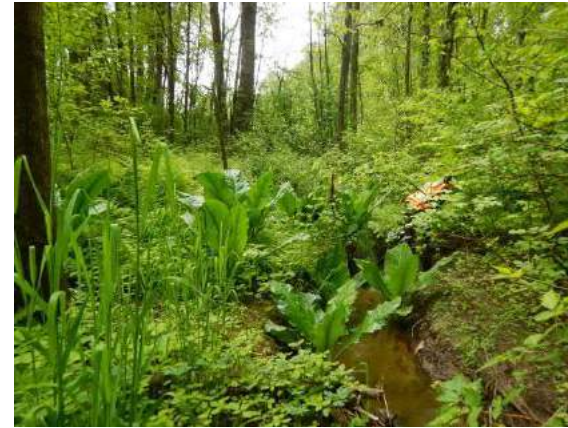
Photo 27: Upper Willband Detailed Assessment
(May 19, 2017)

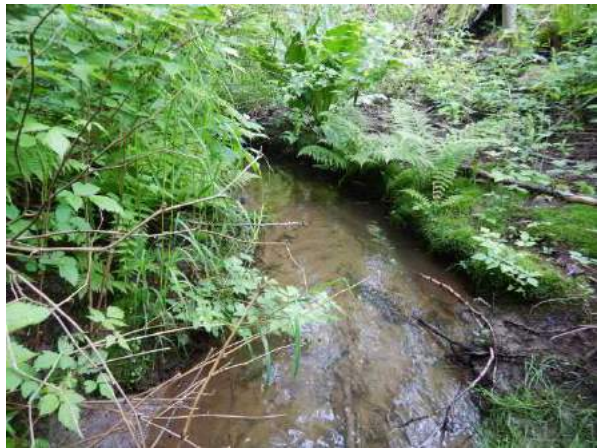
Photo 28: Upper Willband Detailed Assessment
(May 19, 2017)

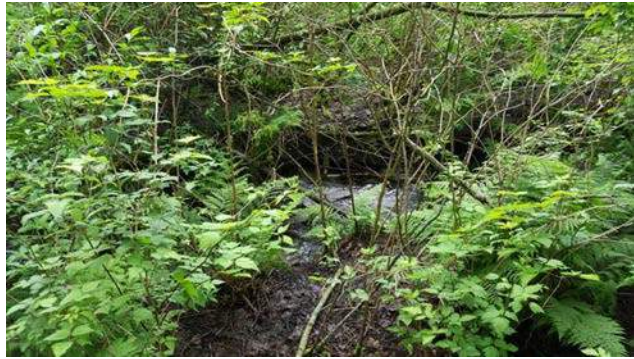
Photo 31: Theissen Creek Detailed Assessment (May 19, 2017)

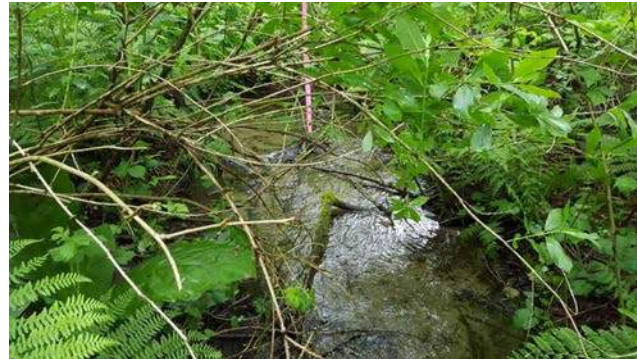
Photo 32: Theissen Creek Detailed Assessment (May 19, 2017)

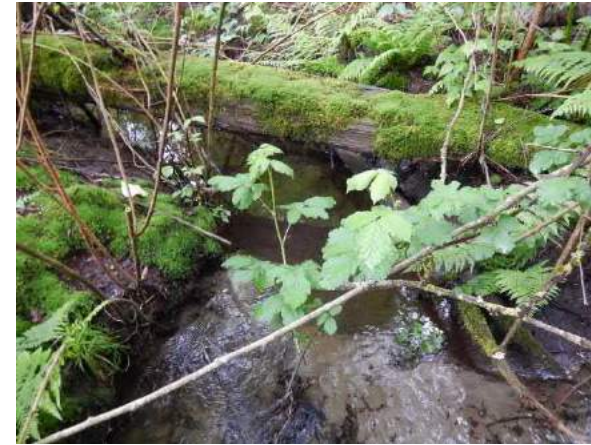
Photo 33: Theissen Creek Detailed Assessment, note Large Woody Debris (May 19, 2017)

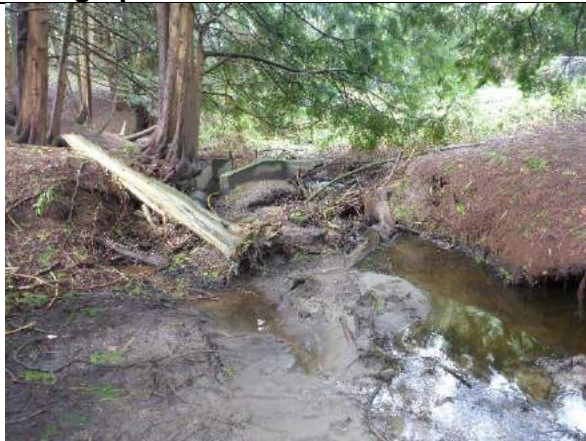
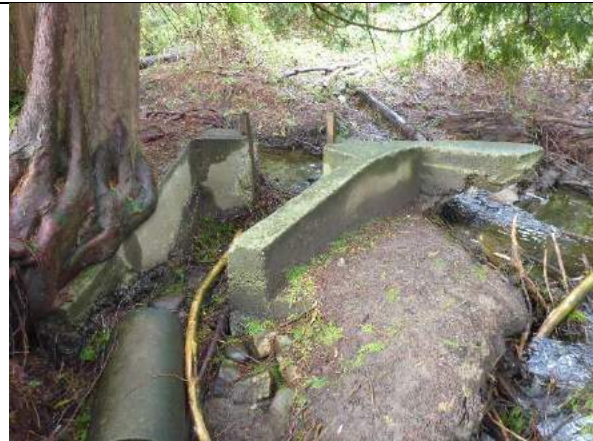
Photo 319

<u>Photo No.</u>	<u>Bearing</u>	<u>Description</u>
319-320	South West	Upstream view at dam
321	North West	Dam
322	South	Upstream view
323	North East	Undercut area
324	South West	Dam
325-326	North	Dam showing left bank
327	South	Upstream view about 20 m above dam showing log across the creek

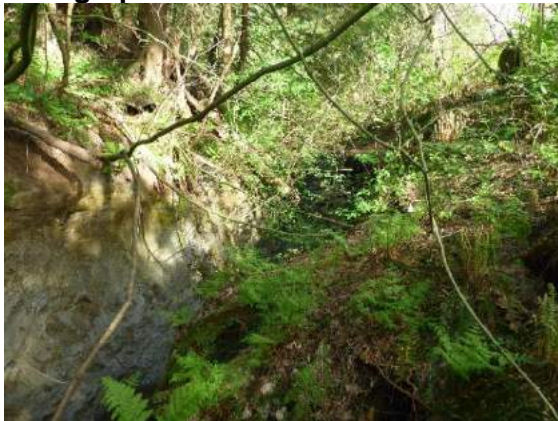
Photo 429

<u>Photo No.</u>	<u>Bearing</u>	<u>Description</u>
429	North West	Upstream view
430	South South East	Downstream view
431	South East	Upstream view, toppled tree
432	South	Upstream view, photo taken approx. 50 m upstream
433	North West	Downstream view, top of erosion area

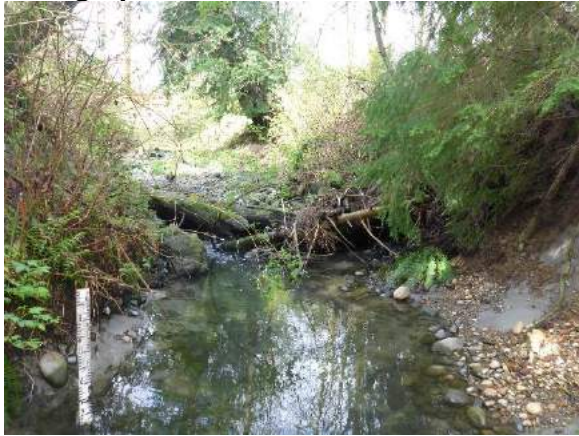
Photo 329

<u>Photo No.</u>	<u>Bearing</u>	<u>Description</u>
329	South West	Upstream view at debris blockage
330	South West	Bank
331	North West	Bank
332	North East	Downstream view
333	Down	Slump
328	North East	Downstream view above blockage
334	South West	Upstream view from bank crest

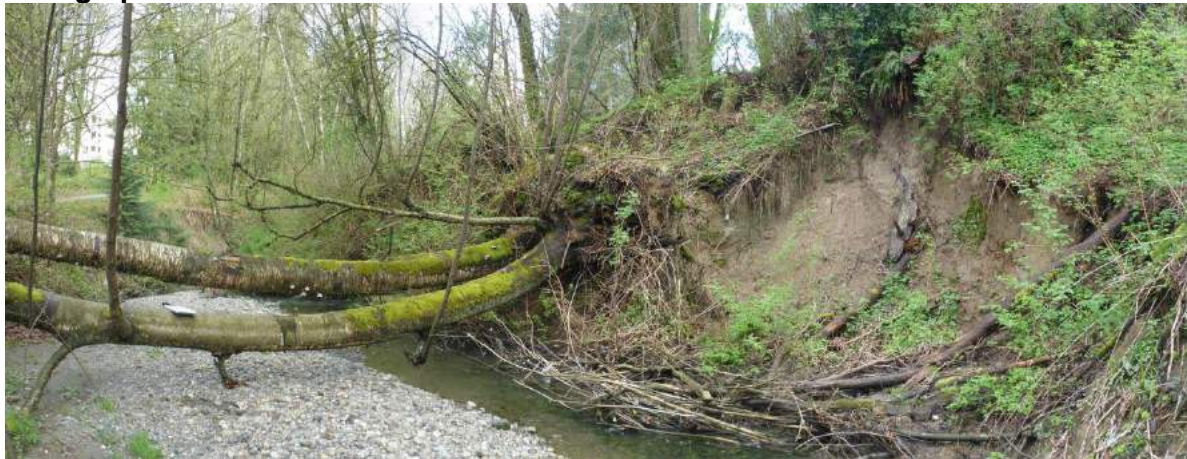
Photos 335-338

<u>Photo No.</u>	<u>Bearing</u>	<u>Description</u>
335-338	North East-North	Right bank erosion panorama
340	Right Bank	Panorama upstream to downstream

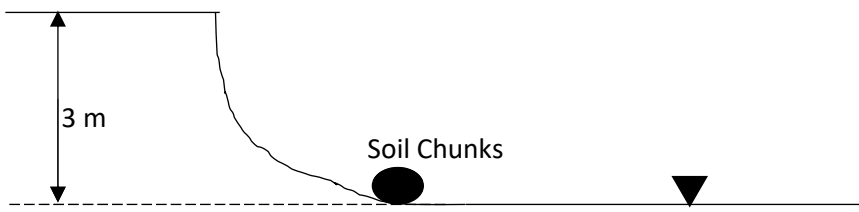
Watercourse Stability Assessment Data Sheet				Report	Horn-03	
Client:	Urban Systems Ltd./Abbotsford			File No.	12189	
Watercourse	Horn Creek			Date:	April 13, 2017	
Site Location	3055 Trafalgar Street			Easting	0550276	
Time	Start:	11:45 a.m.	Bank:	Left	Northing	5434102
	End:	11:55 a.m.			Datum	WGS84
Weather	Sun and clouds			Inspector	BSP	
Type: Erosion						
Description:						
<ul style="list-style-type: none"> - Left bank toe erosion and top of bank sloughing. 						
Slope:						
<ul style="list-style-type: none"> - Toe eroding under high flows on outside bend of creek. Left bank becomes undermined and sloughs/caves in. - Path set back 3 to 4 m from crest. Chunks of soil at base indicating that slope crest is retrogressing at a constant rate. - Black berries hanging over edge of slope. - Some seepage observed out of bank on upstream side. 						
Sketch: (Not to scale. Facing downstream)

Soil and Water Conditions:						
<ul style="list-style-type: none"> - Very stiff, clayey SILT with some sand. 						
Stability Issues:						
<ul style="list-style-type: none"> - Toe erosion and over steep slope weathering. 						
Access:						
<ul style="list-style-type: none"> - Via trail. 						
Comparison to Previous Years:						
<ul style="list-style-type: none"> - First year assessed.

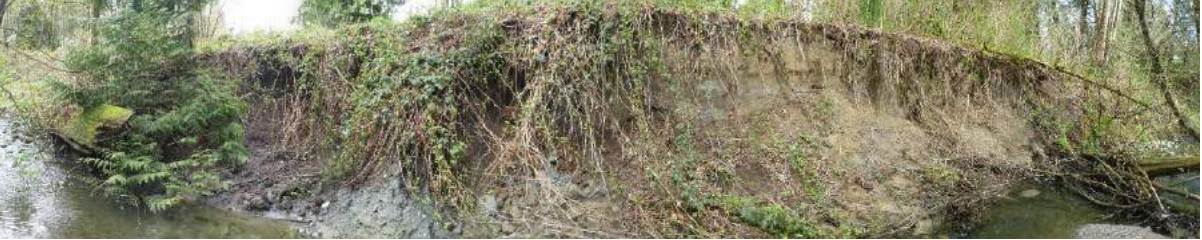
<p>Photo 341-348</p>

<u>Photo No.</u>	<u>Bearing</u>	<u>Description</u>
341-348		Left bank panorama
<p>Photographs:</p>

Risk: Medium
Consequence: <ul style="list-style-type: none">- Path will become undermined.
Likelihood: <ul style="list-style-type: none">- Moderate. Appears to happen continuously in small amounts.- High water flows increase the rate of erosion.
Remedial Options: <ul style="list-style-type: none">- Cut back slope, protect toe, vegetate.- Remove blackberries and vegetate with deep rooting species.

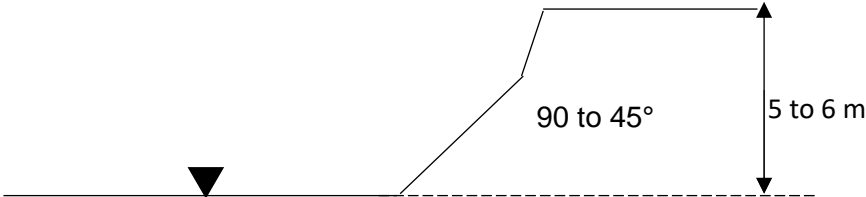
Watercourse Stability Assessment Data Sheet				Report	Horn-04	
Client:	Urban Systems Ltd. / Abbotsford			File No.	12189	
Watercourse	Horn Creek			Date:	April 13, 2017	
Site Location	3055 Trafalgar Street			Easting	0550301	
Time	Start:	11:55 a.m.	Bank:	Right	Northing	5434132
	End:	12:05 p.m.			Datum	WGS84
Weather	Light rain			Inspector	BSP	
Type: Erosion						
Description:						
<ul style="list-style-type: none"> - Right bank erosion and sloughing. 						
Slope:						
<ul style="list-style-type: none"> - 5 to 6 m high near vertical to 45°. - About 20 m long. 						
Sketch: (Not to scale. Facing downstream)

Soil and Water Conditions:						
<ul style="list-style-type: none"> - Stiff, clayey SILT with some sand. 						
Stability Issues:						
<ul style="list-style-type: none"> - Toe eroding in stream causing upper slope to slump and become oversteep 						
Access:						
<ul style="list-style-type: none"> - Via trail

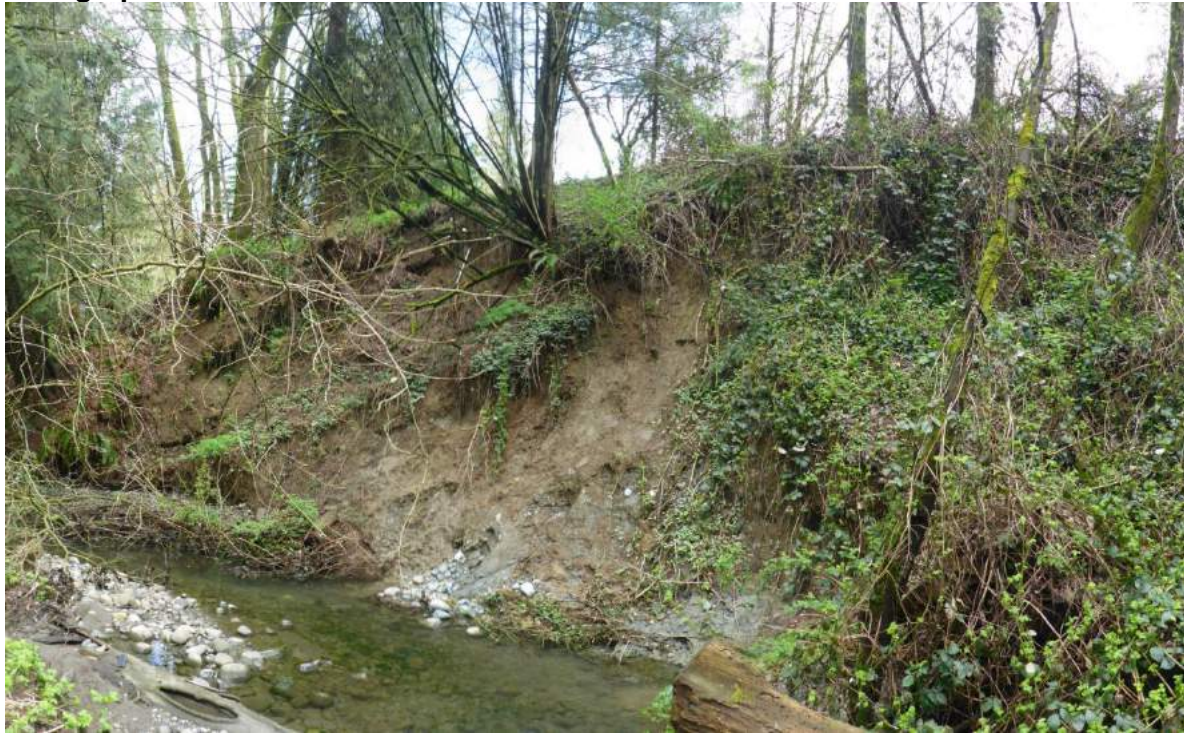
Photos 349-353

<u>Photo No.</u>	<u>Bearing</u>	<u>Description</u>
349-353 353	East North East	Right bank panorama Right bank erosion

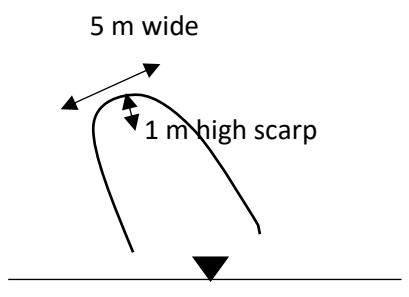
Watercourse Stability Assessment Data Sheet				Report	Horn-05	
Client:	Urban Systems Ltd./Abbotsford			File No.	12189	
Watercourse	Horn Creek			Date:	April 13, 2017	
Site Location	3115 Trafalgar Street			Easting	550317	
Time	Start:	12:05 p.m.	Bank:	Left	Northing	5434222
	End:	12:15 p.m.			Datum	WGS84
Weather	Light Rain			Inspector	BSP	
Type: Existing Slough / Slide						
Description:						
<ul style="list-style-type: none"> - Slide about 1 m deep. 						
Slope:						
<ul style="list-style-type: none"> - Slump/slide on left bank in peat. Soil is saturated, water flowing out of toe. - Scarp about 1 m high and 5 m wide. - Toe will be eroded at high water level. Not currently eroding. 						
Sketch: (Not to scale)

<p>The sketch shows a cross-section of a scarp. A horizontal line at the top is labeled '5 m wide'. A vertical line on the left side of the scarp face is labeled '1 m high scarp'. The scarp face is a curved line sloping down to the right. A horizontal line at the bottom represents the ground level, with a downward-pointing arrow indicating the toe of the scarp.</p>

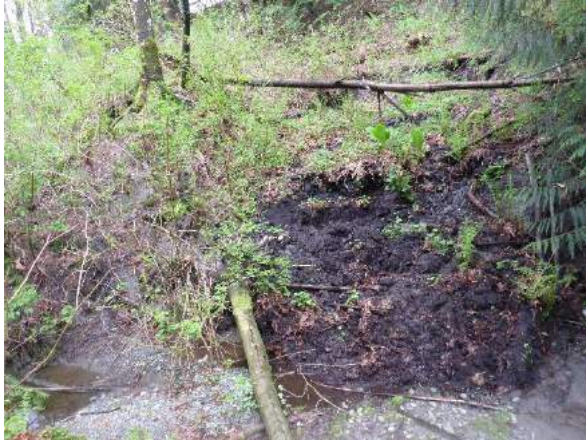
Photo 355

Soil and Water Conditions:						
<ul style="list-style-type: none"> - Peat over stiff silt. 						
Stability Issues:						
<ul style="list-style-type: none"> - Slide will continue to move if toe is eroded. 						
Access:						
<ul style="list-style-type: none"> - Via creek. 						
Comparison to Previous Years:						
<ul style="list-style-type: none"> - First year assessed.

<u>Photo No.</u>	<u>Bearing</u>	<u>Description</u>
355	South West	Slide
354	North West	About 10 m upstream of slide, left bank
356	North	Downstream view
357	South	Upstream view

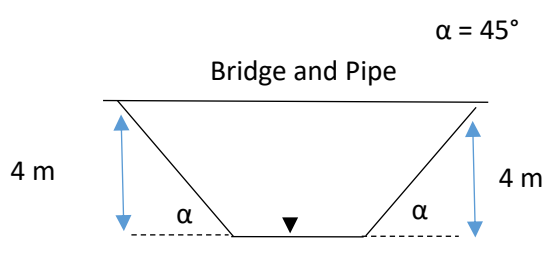
Watercourse Stability Assessment Data Sheet				Report	Horn-06
Client:	Urban Systems Ltd./Abbotsford			File No.	12189
Watercourse	Horn Creek			Date:	April 13, 2017
Site Location	Pedestrian Bridge and Ariel Pipe			Easting	550373
Time	Start:	12:15 p.m.	Bank:	Left/Right	Northing
	End:	12:30 p.m.			5434297
				Datum	WGS84
Weather	Sun and clouds			Inspector	BSP
Type: Existing Slough-Slide					
Description:					
<ul style="list-style-type: none"> - Erosion of left bank under bridge and upstream/downstream sporadically. 					
Slope:					
<ul style="list-style-type: none"> - Slope banks are about 4 m high and slope near vertical. - The left bank beneath the bridge abutment is at about a 45° slope. The slope is covered in coco matting. Erosion is occurring underneath. - Minimal erosion under pipe, but bank is over-steepened. - Bridge on lock blocks. 					
Sketch: (Not to scale. Facing downstream)

Soil and Water Conditions:					
<ul style="list-style-type: none"> - Stiff SILT with some clay and sand. Angular gravel and cobble fill above. 					
Stability Issues:					
<ul style="list-style-type: none"> - Continued erosion will undermine the bridge abutments and pipe supports. 					
Access:					
<ul style="list-style-type: none"> - Via trail. 					
Comparison to Previous Years:					
<ul style="list-style-type: none"> - First year assessed.

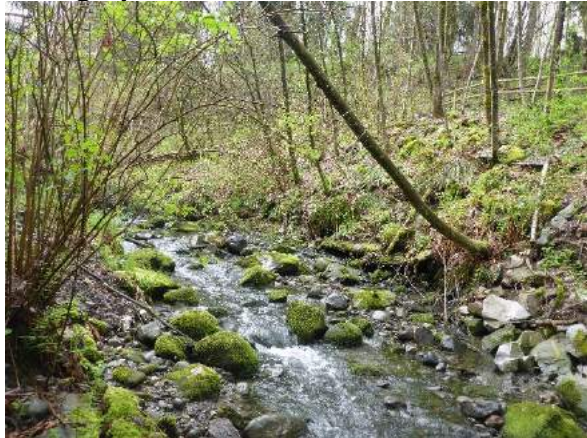
Photo 363

<u>Photo No.</u>	<u>Bearing</u>	<u>Description</u>
363	South West	Upstream view
364	South East	Right bank pipe support
365	South East	Right bank under bridge
366	South	Upstream view
367	South West	Downstream view
362	South West	Left bank at bridge
358-359	Left Bank	Upstream of bridge erosion

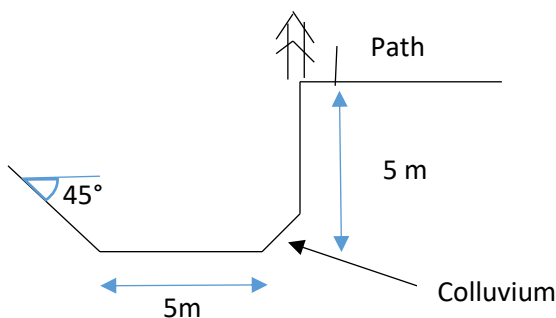
Watercourse Stability Assessment Data Sheet				Report	Horn-07	
Client:	Urban Systems Ltd. / Abbotsford			File No.	12189	
Watercourse	Horn Creek			Date:	April 25, 2017	
Site Location	About 50 m downstream of pipe and bridge			Easting	0550377	
Time	Start:	10:00 a.m.	Bank:	Right	Northing	5434314
	End:	10:15 a.m.			Datum	WGS84
Weather	Mix of sun and clouds			Inspector	BSP	
Type: Erosion						
Description:						
<ul style="list-style-type: none"> - Undermining of right bank may impact the path. 						
Slope:						
<ul style="list-style-type: none"> - About 5 m high near vertical slope on right bank, which undercut tree roots at the crest of the slope. - Colluvial deposits had accumulated at the toe of the slope. - Some sloughing observed on left bank. 						
Sketch: (Not to scale. Facing downstream)

<p>The sketch shows a cross-section of a slope. On the left, a 45-degree angle is indicated. The slope descends from a horizontal line representing a path. A vertical double-headed arrow indicates a height of 5 m from the toe of the slope to the path. A horizontal double-headed arrow at the base indicates a width of 5 m. At the toe of the slope, there is a pile of material labeled 'Colluvium'. A path is shown at the top of the slope with a tree icon above it.</p>

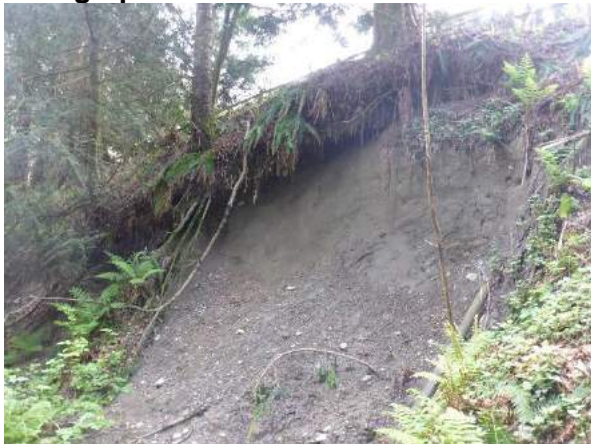
Photo 436

Soil and Water Conditions:						
<ul style="list-style-type: none"> - Slope was generally dry, some wet spots in the slough at the base. - The lower 4 m of the slope generally comprised hard, grey, sandy SILT and CLAY. - The upper 1 m of the slope comprised sandy, cobbly GRAVEL. 						
Stability Issues:						
<ul style="list-style-type: none"> - The oversteep slope will very likely continue to slough and retrogress. 						
Access:						
<ul style="list-style-type: none"> - Via creek or path, likely difficult. 						
Comparison to Previous Years:						
<ul style="list-style-type: none"> - First year assessed.

<u>Photo No.</u>	<u>Bearing</u>	<u>Description</u>
436	East	Right bank, erosion feature
437	North East	Left bank
438	North East	Downstream view
439	South West	Upstream view
440	East	Bank soil

Risk: High
Consequence: <ul style="list-style-type: none">- Retrogressing slope will undermine the path and houses above.- Erosion will cause sedimentation in creek
Likelihood: <ul style="list-style-type: none">- The slope could retrogress quickly if the trees fall.
Remedial Options: <ul style="list-style-type: none">- Review the tree health by an arborist.- Build up the base of the slope and cut back the slope crest to reduce overall slope angle.- Geotextile reinforced slope, mechanically stabilized earth wall, and/or soil bio-engineering to buttress toe.

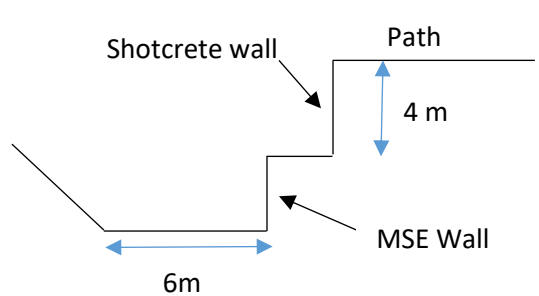
Watercourse Stability Assessment Data Sheet				Report	Horn-08	
Client:	Urban Systems Ltd./Abbotsford			File No.	12189	
Watercourse	Horn Creek			Date:	April 25, 2017	
Site Location	Between Theissen and Bridge / pipe			Easting	0550466	
Time	Start:	10:15 a.m.	Bank:	Right	Northing	5434369
	End:	10:30 a.m.			Datum	WGS84
Weather	Mix of sun and clouds			Inspector	BSP	
Type: Erosion						
Description:						
<ul style="list-style-type: none"> - Erosion on upstream side of shotcrete and downstream mechanically stabilized earth (MSE) wall toe. 						
Slope:						
<ul style="list-style-type: none"> - The slope on upstream of feature above the portion of the shotcrete wall upstream of the lock block MSE wall exhibits erosion over a height of about 2 to 3 m. The eroded slope is supported by tree roots. - Minor undermining of the MSE wall on downstream end of feature. 						
Sketch: (Not to scale. Facing downstream)

<p>The sketch shows a cross-section of a watercourse feature. On the left, a sloped area leads to a vertical 'Shotcrete wall'. To the right of the shotcrete wall is a 'Path' with a vertical height of 4 m. Below the path is an 'MSE Wall' (Mechanically Stabilized Earth wall) with a horizontal width of 6 m. Arrows point from the labels to the corresponding parts of the sketch.</p>						
Soil and Water Conditions:						
<ul style="list-style-type: none"> - The eroded area comprised brown, silty SAND and GRAVEL. 						
Stability Issues:						
<ul style="list-style-type: none"> - Minor sloughing is likely to continue within the eroded area. 						
Access:						
<ul style="list-style-type: none"> - Via Creek 						
Comparison to Previous Years:						
<ul style="list-style-type: none"> - First year assessed.

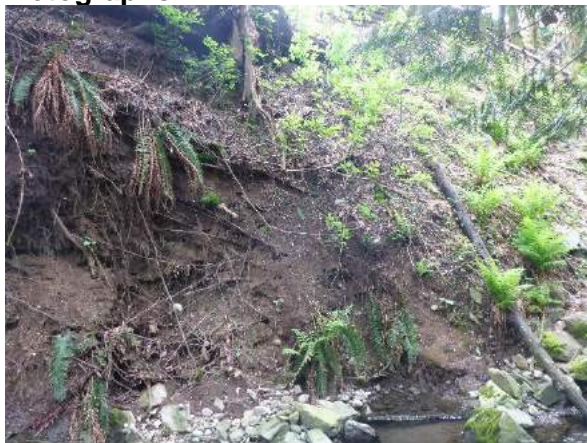
Photo 443

<u>Photo No.</u>	<u>Bearing</u>	<u>Description</u>
443	South East	Feature on right bank
444	East	Feature on right bank
445	South East	Panorama view, upstream on right of center of picture, downstream on left of center
446	East	Shotcrete retaining path
447	North	Downstream view
448	South East	Erosion feature on right bank
449	North East	Downstream view of corner undermining of MSE wall

Risk: Medium
Consequence: <ul style="list-style-type: none">- Erosion of the slope may undermine the path.- Erosion will cause sedimentation in creek
Likelihood: <ul style="list-style-type: none">- Erosion appears to advance at a slow rate.
Remedial Options: <ul style="list-style-type: none">- Monitor the eroded area.- Apply additional shotcrete if erosion continues- Place large rip-rap at the toe of the MSE wall for protection.

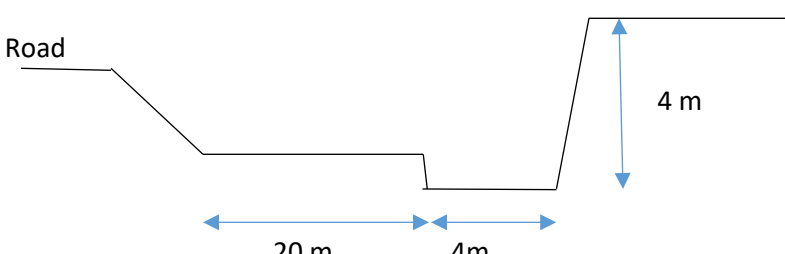
Watercourse Stability Assessment Data Sheet				Report	Horn-09
Client:	Urban Systems Ltd. / Abbotsford			File No.	12189
Watercourse	Horn Creek			Date:	April 25, 2017
Site Location	3192 Horn Street			Easting	0550648
Time	Start:	10:35 a.m.	Bank:	Right	Northing
	End:	10:50 a.m.			
Weather	Mix of sun and clouds			Datum	WGS84
				Inspector	BSP
Type: Erosion					
Description:					
<ul style="list-style-type: none"> - Erosion of the right bank due to undermining of the toe. 					
Slope:					
<ul style="list-style-type: none"> - The erosion feature is about 4 m high and 25 m long. 					
Sketch: (Not to scale. Facing downstream)

Soil and Water Conditions:					
<ul style="list-style-type: none"> - The slope comprises a stratified layering of silty SAND and GRAVEL, with some layers of sand. 					
Stability Issues:					
<ul style="list-style-type: none"> - Erosion at the toe causes undermining of the slope.

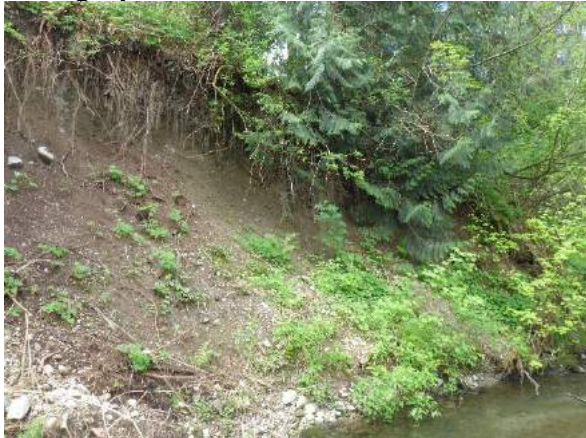
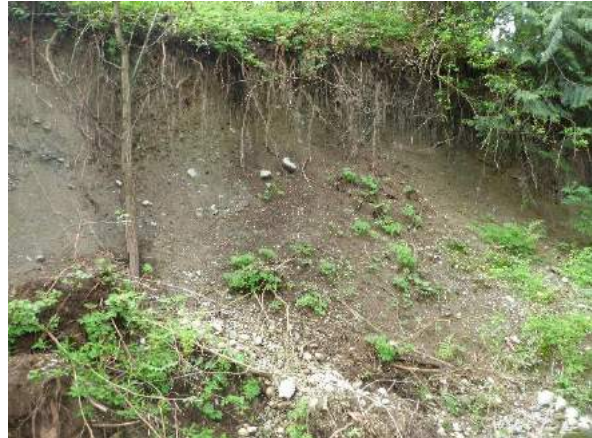
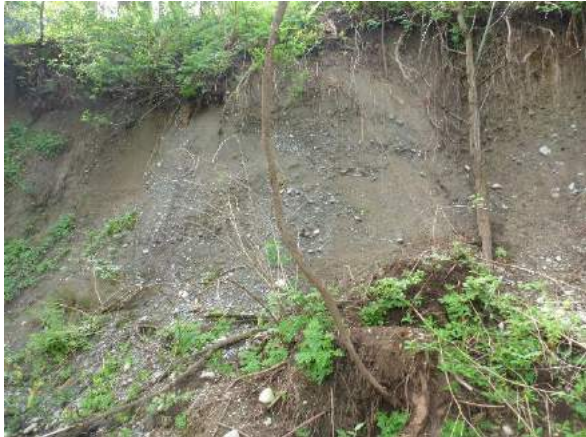
<u>Photo No.</u>	<u>Bearing</u>	<u>Description</u>
450	South West	Right bank
451	South West	Right bank
452	South	Right bank
453	South East	Downstream view, right bank
454	South	Panorama view from upstream (right) to downstream (left)

Risk: Low
Consequence: <ul style="list-style-type: none">- No nearby houses or infrastructure.- Erosion will cause sedimentation in creek
Likelihood: <ul style="list-style-type: none">- Erosion appears to be ongoing.
Remedial Options: <ul style="list-style-type: none">- Place erosion protection at the toe of the slope to reduce toe erosion.- Cut back crest of slope and vegetate

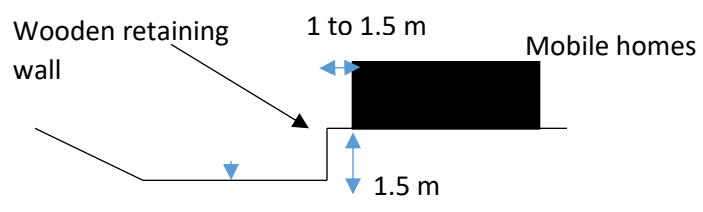
Watercourse Stability Assessment Data Sheet				Report	Thiessen-01	
Client:	Urban Systems Ltd. / Abbotsford			File No.	12189	
Watercourse	Thiessen Creek			Date:	April 13, 2017	
Site Location	Behind mobile homes			Easting	550702	
Time	Start:	1:15 p.m.	Bank:	Right	Northing	5434676
	End:	1:30 p.m.			Datum	WGS84
Weather	Sun and clouds			Inspector	BSP	
Type: Erosion						
Description:						
<ul style="list-style-type: none"> - Property manager reported erosion behind mobile homes 						
Slope:						
<ul style="list-style-type: none"> - Ground generally relatively flat. - Creek about 0.5 to 1 m below surrounding banks. - Mobile homes approximately 1 m to 1.5 m setback from the retaining wall. 						
Sketch: (Not to scale. Facing downstream)

<p>The sketch illustrates the site layout facing downstream. On the left, a wooden retaining wall is shown. To its right, mobile homes are situated, with a setback of 1 to 1.5 meters from the wall. The creek is located 1.5 meters below the level of the retaining wall.</p>

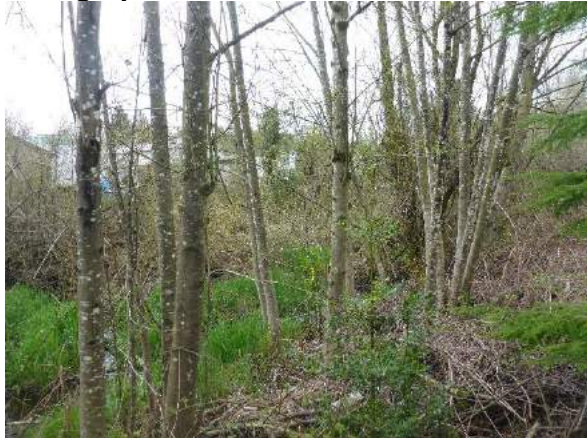
Photo 382

<u>Photo No.</u>	<u>Bearing</u>	<u>Description</u>
382	South West	Across Creek view
383	South	Downstream view
385	South West West	Upstream view, retaining walls and mobile homes
386	South West	Mobile homes and retaining walls

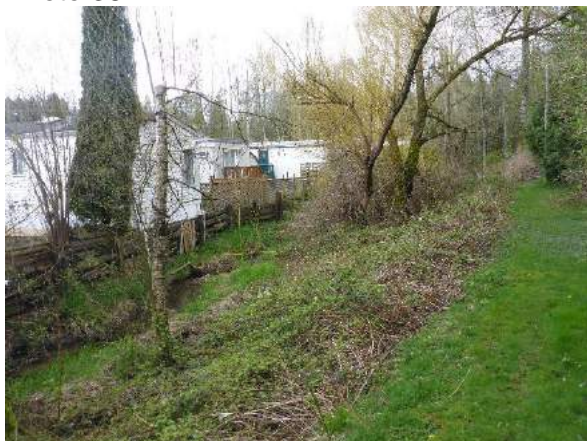
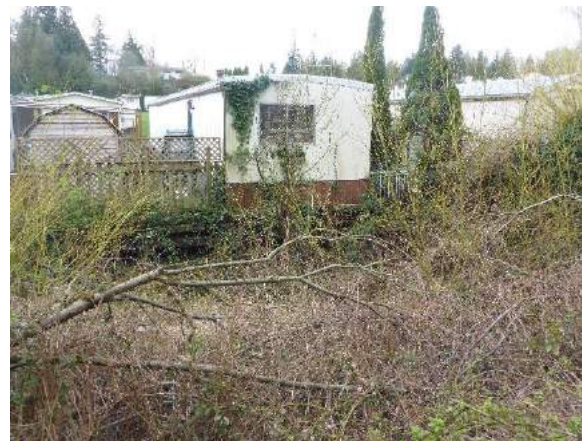
Soil and Water Conditions:						
<ul style="list-style-type: none"> - Ground generally saturated - Soil not observed 						
Stability Issues:						
<ul style="list-style-type: none"> - Retaining wall appears to be rotting. 						
Access:						
<ul style="list-style-type: none"> - Via mobile home park. 						
Comparison to Previous Years:						
<ul style="list-style-type: none"> - First year assessed.

Risk: Medium
Consequence: <ul style="list-style-type: none">- Degrading retaining walls could potentially impact the mobile homes and creek.
Likelihood: <ul style="list-style-type: none">- Slow rotting of wood, could increase during higher flows.
Remedial Options: <ul style="list-style-type: none">- Remove or rebuild retaining walls.- Recommend property and home owners retain geotechnical engineer to assess foundations for mobile homes and condition of retaining wall.- Move mobile homes away from the creek to reduce potential for undermining.

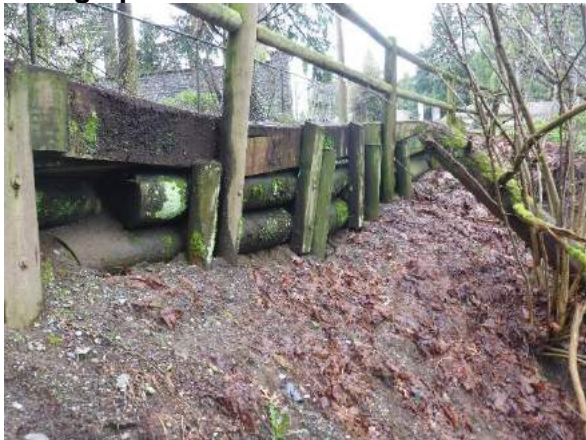
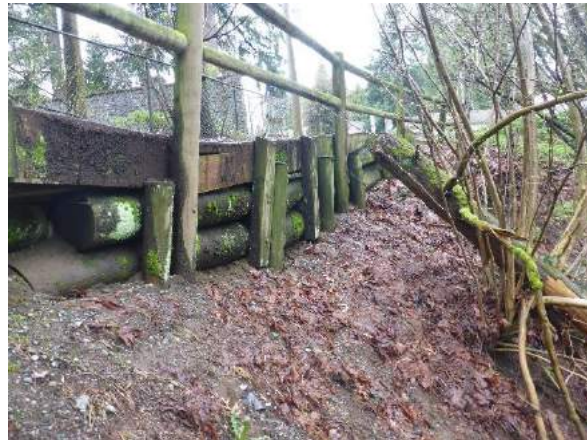
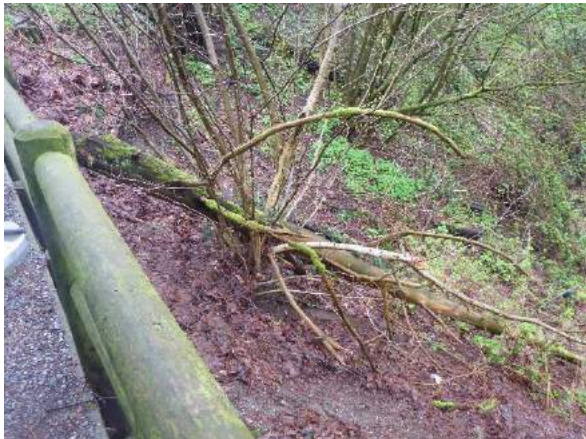
Soil and Water Conditions:					
<ul style="list-style-type: none"> - Compact/firm, brown, moist SILT and SAND. - Path comprises 19 mm minus SAND and GRAVEL. 					
Stability Issues:					
<ul style="list-style-type: none"> - Bank over-steepened, erosion and raveling occurring. - Rubbish on slope (old Christmas trees). - Some leaves appear piled on the north end. 					
Access:					
<ul style="list-style-type: none"> - Easy. Access via path from Bourquin Street. 					
Comparison to Previous Years:					
<ul style="list-style-type: none"> - First year assessed.

<u>Photo No.</u>	<u>Bearing</u>	<u>Description</u>
309, 310, 317	North	Retaining wall
311, 315, 316	North East	Downslope
312, 318	South	Retaining wall
313	Down	Soil on slope
314	North	Along path at top of slope

Risk: Medium
Consequence: <ul style="list-style-type: none">- Environmental damage to creek and habitat if retaining wall fails.
Likelihood: <ul style="list-style-type: none">- Erosion appears contained to small sloughs on surface.
Remedial Options: <ul style="list-style-type: none">- Cut back slope crest and vegetate if possible to move path.- If retaining wall is designed to remain, monitor and remediate as required. Complete revegetation and / or soil bio-engineering to stabilize surficial sloughing below retaining wall.

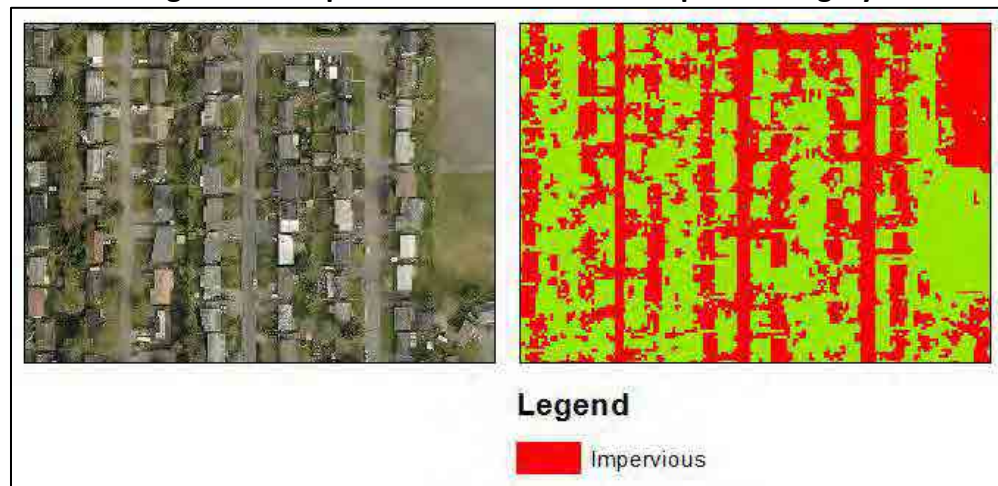
Figure 3.1: Impervious Areas from Orthophoto Imagery

The impervious percentage for each subcatchment was determined based on the airphoto imagery analysis completed by USL. It was initially assumed that 50% of runoff from impervious areas is routed to pervious surfaces. **Figure 3.1** illustrates the airphoto and the corresponding impervious areas generated from the imagery analysis of a representative area.

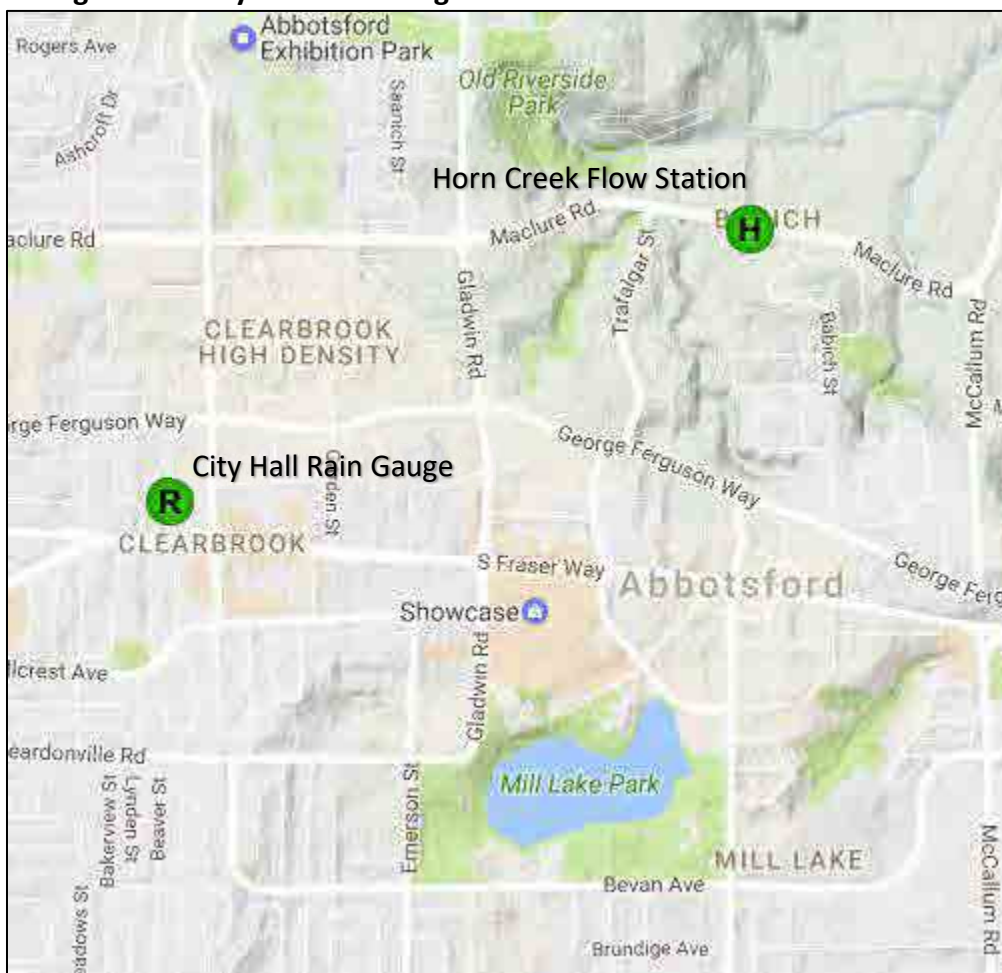
Figure 4.1: City Hall Rain Gauge and Horn Creek Flow Station Location

Rain gauge data was used to load precipitation for the stormwater model's simulations. Principal input properties used by the model include time interval, rainfall intensity and volume. Precipitation data from the City Hall rain gauge was obtained from FlowWorks. This rain gauge was selected as it was within the Willband Creek drainage basin. The location of the City Hall rain gauge is shown in **Figure 4.1**.

Data from the Horn Creek flow station was obtained from FlowWorks. This station is the only flow station within the Willband Creek drainage basin. The location of the Horn Creek flow station is shown in **Figure 4.1**.
